No. 2

Spantax, Convair CV 990, EC-BNM accident at Stockholm/Arlanda Airport, Sweden, on 5 January 1970. Report, dated 23 December 1970, released by the Board of Civil Aviation, Sweden

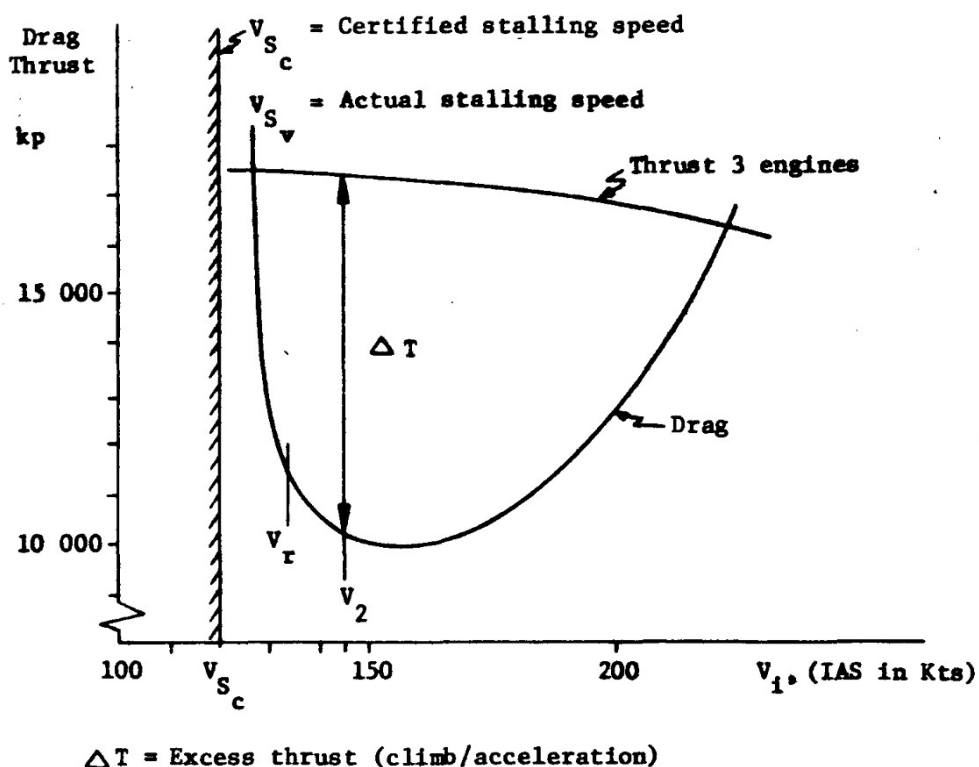
The foregoing situation is worthy of attention when considering the performance and aerodynamics of the aircraft. The drag curve of the Convair Coronado CV 990 in the actual configuration present in this accident (take-off weight and flap setting) is illustrated as follows:

The chart shows drag and thrust vs speed. The effect of the landing gear and trimmed yaw is not included. The chart illustrates two stall speeds. The lowest one, V_{Sc} , is the one obtained during normal certification flight, when the flight path is somewhat curved so that the load factor is less than one. (When the flight path is negatively curved the wingload will be reduced, resulting in a lower stall speed than that obtained in level flight.) The real stall speed is shown by V_{sv} . According to the certification regulations, the climb-out speed (V_2) must not be less than $1.2 V_{Sc}$. As shown in the chart, the margin above actual stall is lower. Furthermore, the climb-out speed lies within that area where the drag increases considerably when the speed is reduced, which implies high stall risk.

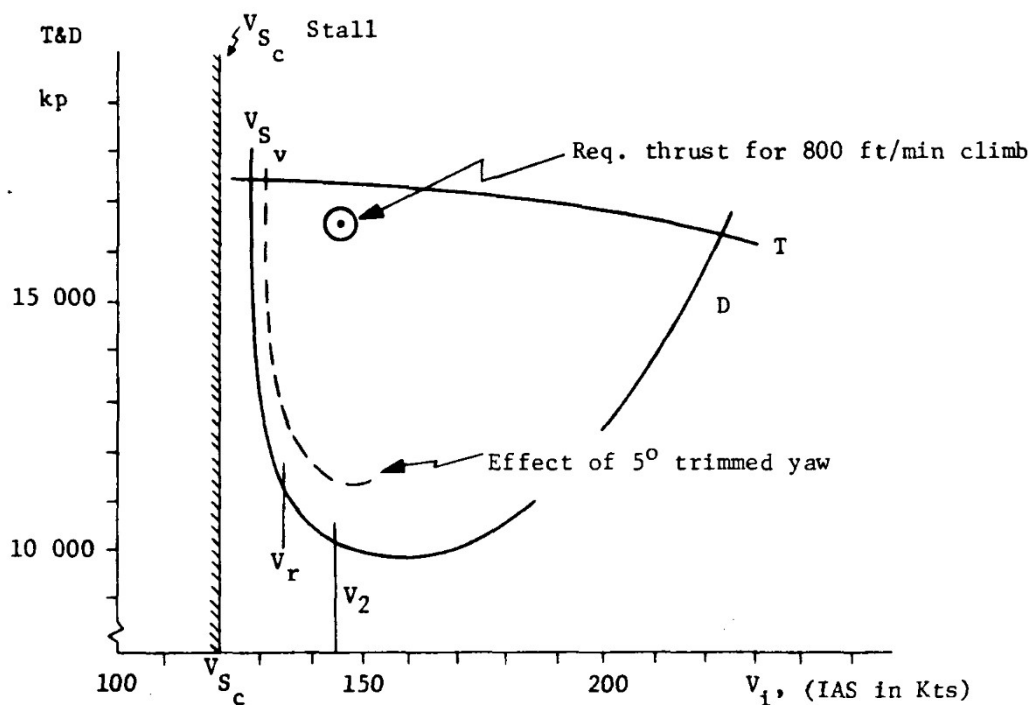
A yawed condition just after lift-off may have a large effect on drag. The first thing to happen when a swept wing aircraft yaws is that the lift on the wing "moving forwards" increases and the lift on the wing "moving backwards" decreases. The resulting effect is a rolling moment that has to be counteracted by applying spoilers/aileron. A combination of spoiler deflection and trimmed yaw results in a considerable drag increase. Furthermore, maximum attainable lift will decrease on the wing "moving backwards" as a result of increased disturbances of the airflow around the engine pylons at the wing leading edge and also as a result of increased spanwise boundary layer flow. At the same time, as the lateral control spoiler goes up, the maximum lift of the wing "moving forwards" decreases. Thus, increased drag is obtained in combination with decreased maximum lift, and the margin to stall decreases. An illustration of the effect of a trimmed 5° yaw is shown in the following chart:

In referring to this chart it should be noted that the increase of drag and stalling speed is based on somewhat uncertain wind tunnel data and that the effect may be greater than shown. If the 5° yaw was combined with a 5° bank to the right, the result would have been a turn that, on the whole, agrees with the site of impact. This does not mean that the side-slip and consequently the spoiler deflection may not have varied during the climb, and the increased drag may at times have been greater than shown in the chart.

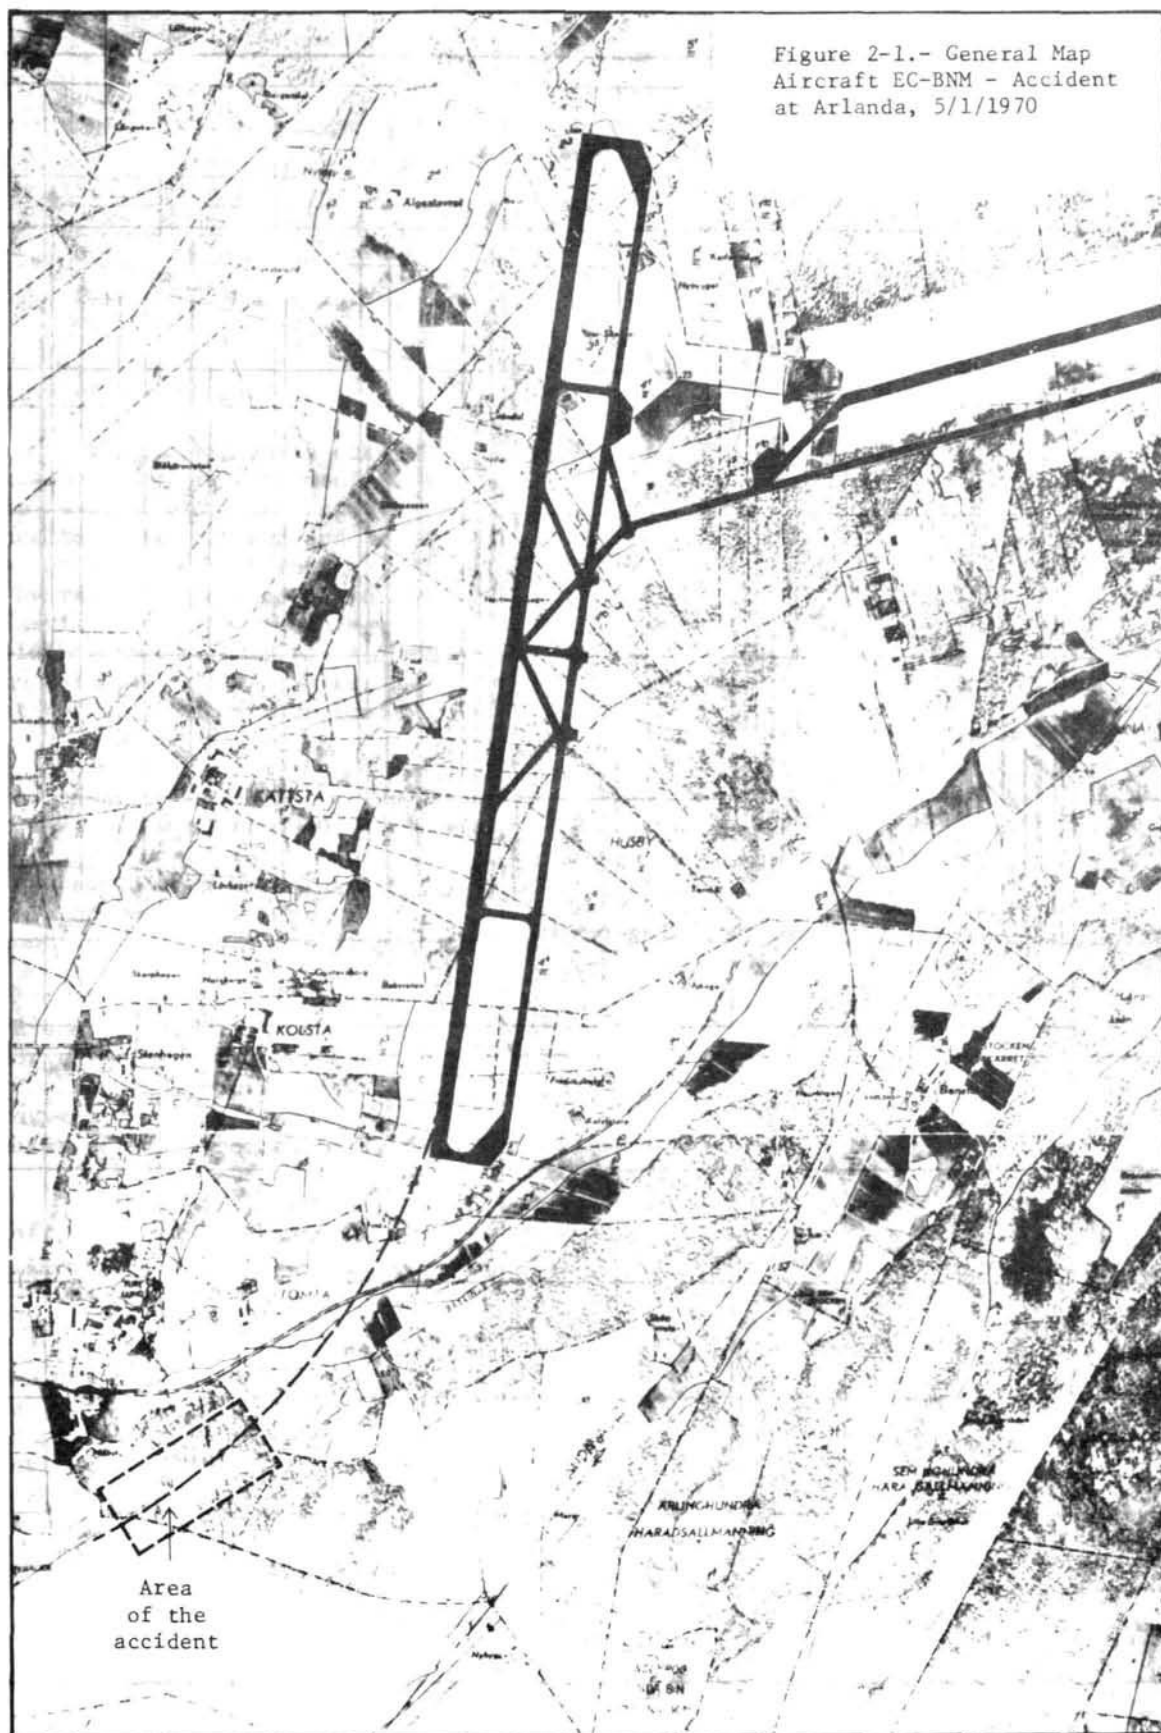
Whilst in a right bank of 4-6° the aircraft collided with tree-tops approximately 26 m above and 1 060 m from the far end of Runway 19, or about 1 800 m from the point of lift-off, having turned through about 25 degrees from the runway heading. The aircraft came to a final stop approximately 500 m after first contact with the trees on a heading of 240° (see Fig. 2-1). The accident occurred at 2225 hours at night in complete darkness.

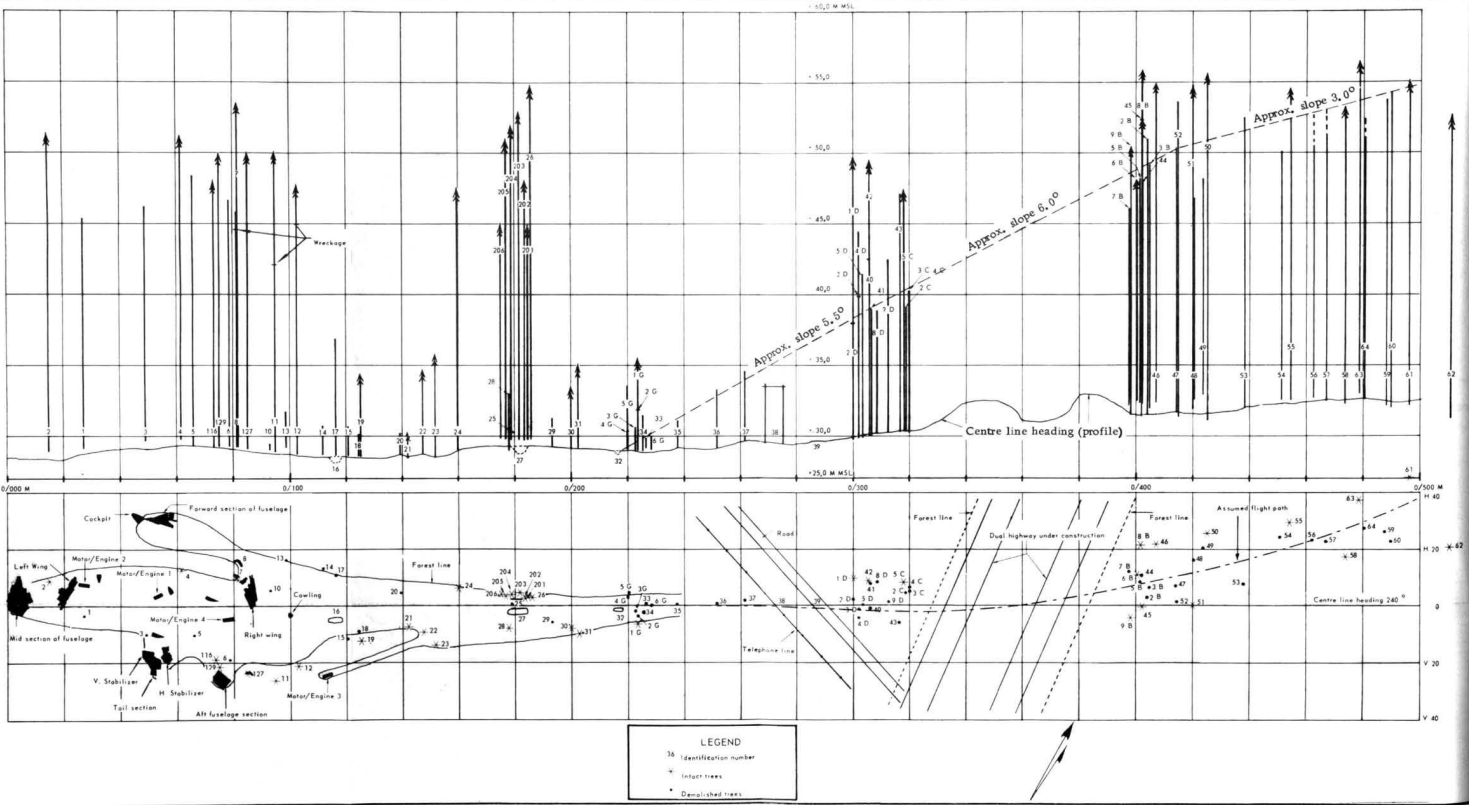
Figure 2-2

The aircraft then travelled in an area free from trees, about 70 m in length, and after that encountered some trees. The cuts in the trees indicated a down slope of about 6° and a bank angle to the right of 30°. Between 200 m and 400 m after the point of initial impact there were only small trees and a marsh. The clipped right wing collided with the ground approximately 250 m after the point of initial impact and the aircraft started to disintegrate; the main parts of the wreckage were found between 410 and 490 m after the point of initial impact. (See Fig. 2-2.)
