RAAD VOOR DE LUCHTVAART

Netherlands Aviation
Safety Board

FINAL REPORT

OF THE INVESTIGATION INTO THE ACCIDENT WITH THE COLLISION
OF KLM FLIGHT 4805, BOEING 747-206B, PH-BUF AND
PAN AMERICAN FLIGHT 1736, BOEING 747-121, N736PA
AT TENERIFE AIRPORT, SPAIN ON 27 MARCH 1977

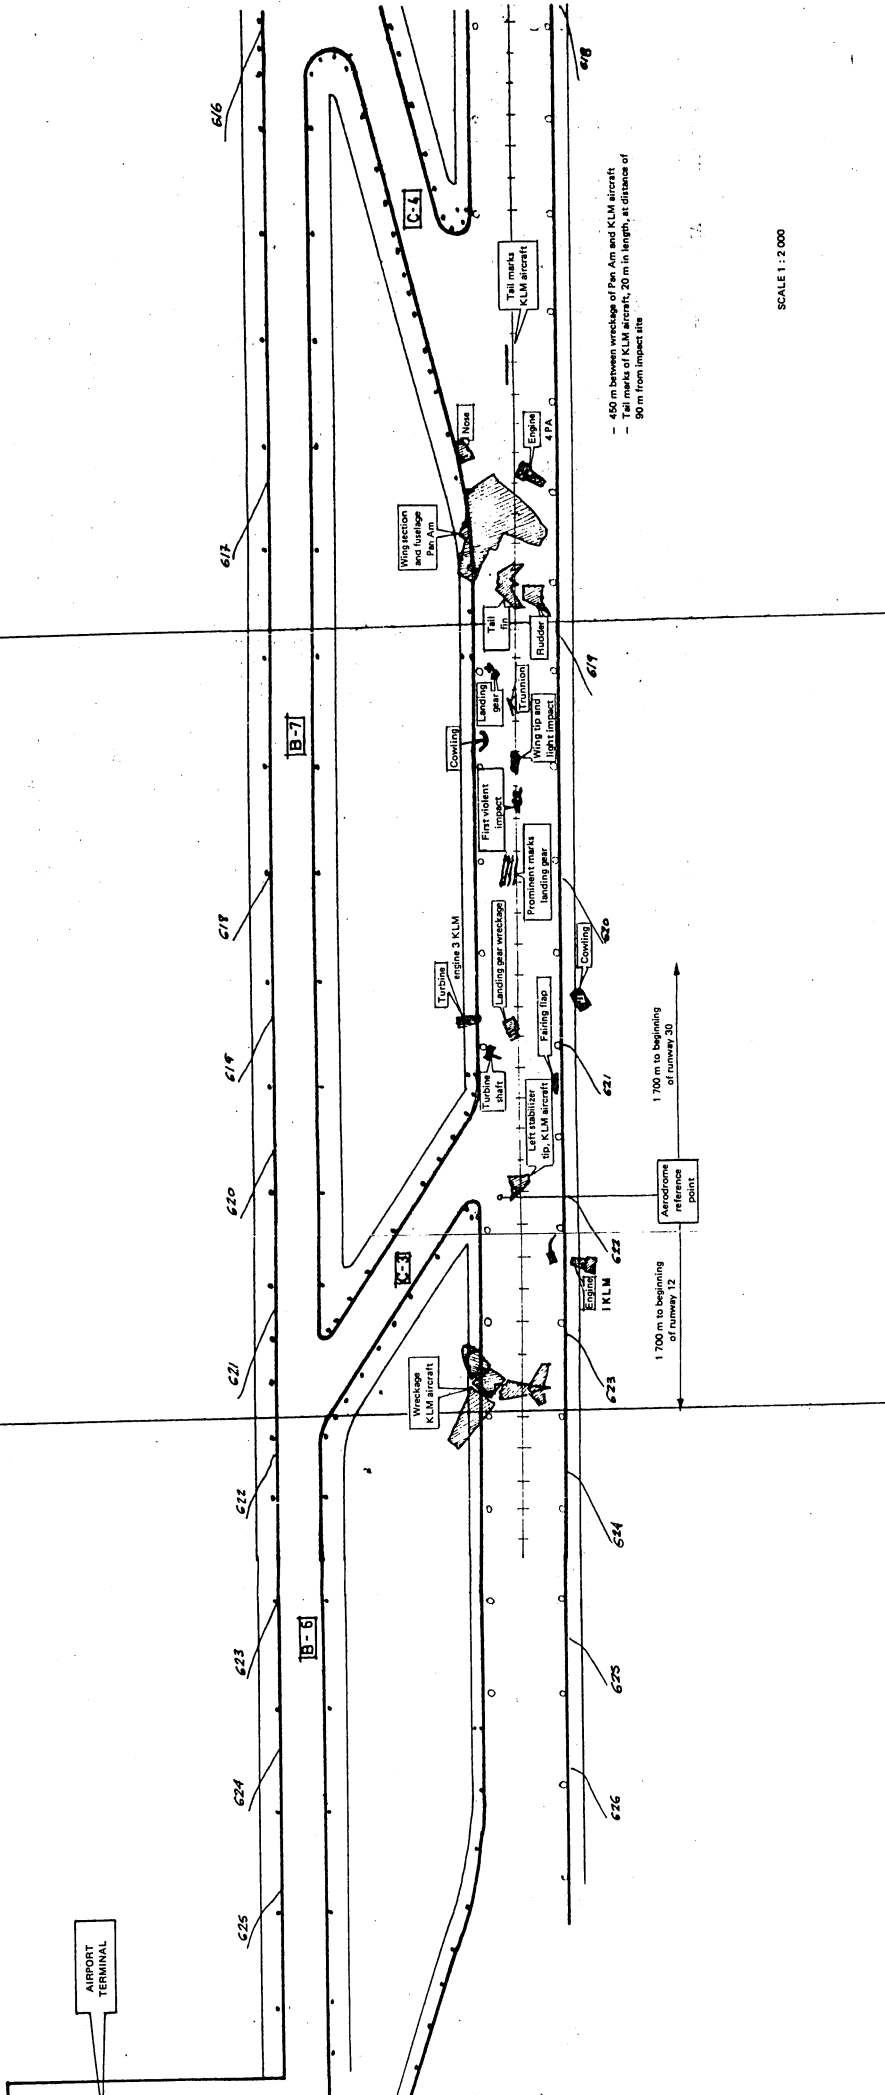
There is no indication of any failure prior to the impact. The distance from the approach end of runway 30 to the Pan Am wreckage was about 1 385 m. From here to the main KLM wreckage there was a distance of about 450 m.

- 450 m between wreckage of Ples Am and KLM aircraft
- Tail marks of KLM aircraft, 20 m in length, at distance of 90 m from impact site
